# TECHNICAL INFORMATION

## CONDUCTION AND FAILURE MECHANISMS IN BARIUM TITANATE BASED CERAMICS UNDER HIGHLY ACCELERATED CONDITIONS

B. S. Rawal and N. H. Chan  
AVX Corporation  
Corporate Research Laboratory  
P.O. Box 867  
Myrtle Beach, SC 29577

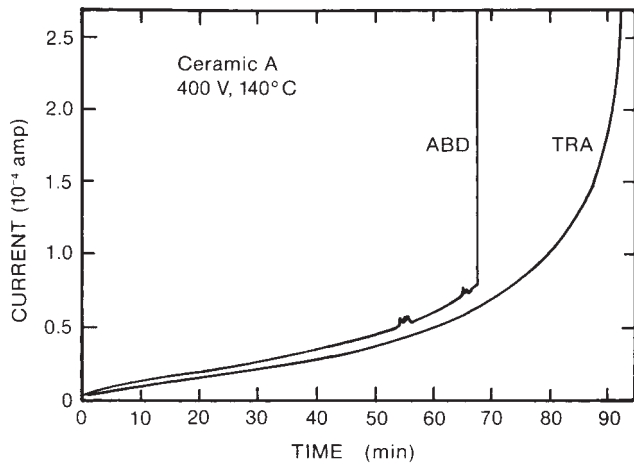
Of about 1,000 samples of various ceramics tested so far, two types of failures have been observed in the dielectric. One is an abrupt burst of current which results in an immediate breakdown (henceforth referred to as avalanche breakdown, or ABD). The other failure is a much more gradual increase of leakage current which leads to self-heating and its subsequent failure (henceforth referred to as thermal runaway, or TRA). A typical current-time recording is shown in Figure 1 for ceramic A. The gradual increase of leakage current is a necessary condition for the thermal runaway process but not for the avalanche breakdown process.

Figure 1. Leakage Current as a Function of Time Under High Temperature and High Voltage Stresses

It should be noted that at very high voltages ( $\geq$  four times rated voltage) and/or at very high temperatures ( $\geq 140^\circ\text{C}$ ), current bursts are much more prevalent in units exhibiting the avalanche breakdown process compared to units exhibiting the thermal runaway failure mode. These current bursts are postulated to result from yielding of weak spots or flaws in the dielectric. The earlier the current burst occurs, the more likely the early failure of a unit. Extensive examination of various dielectric materials at lower voltages and/or lower temperatures shows no indication or presence of any of these current bursts.

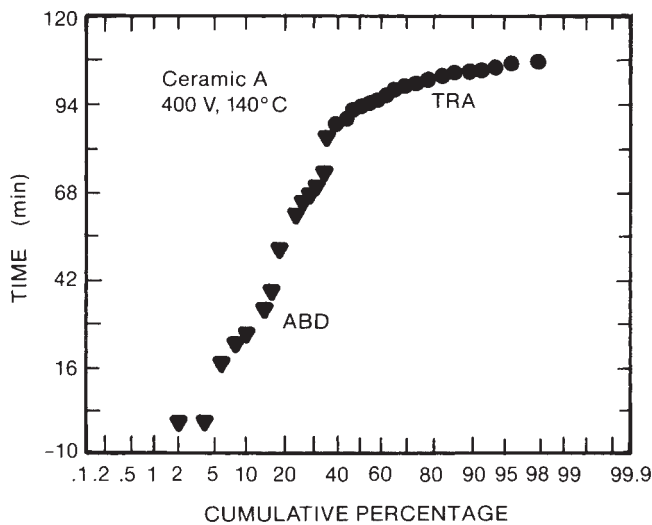
A normal failure probability plot of a laboratory prepared ceramic A tested at  $140^\circ\text{C}$ , 400 VDC is shown in Figure 2. These test conditions are highly accelerated to ease the evaluation of the parts, and the results should be carefully evaluated before making any conclusions about the reliability of these parts.

Figure 2. Normal Failure Probability Plot of Ceramic A with Both ABD and TRA Failures

A large deviation from a normal distribution indicated in the figure also signifies two different failure modes. If one plots the population of each failure mode into a separate figure, one would see a normal distribution\* in each case as shown in Figures 3 and 4, respectively. Each of them has a distinct mean time to failure (MTTF), and the shorter MTTF always corresponds to the group failing by the avalanche breakdown process (within statistical error) because TRA sets the upper limit.

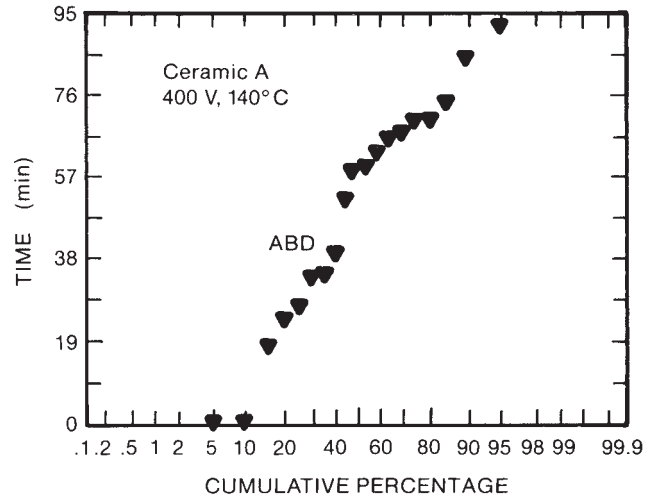
Figure 3. Normal Failure Probability Plot of Ceramic A with ABD Failures Only

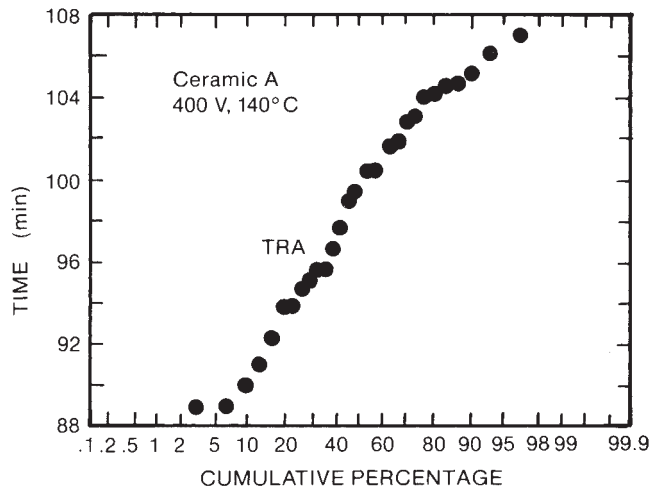
Figure 4. Normal Failure Probability Plot of Ceramic A with TRA Failures Only

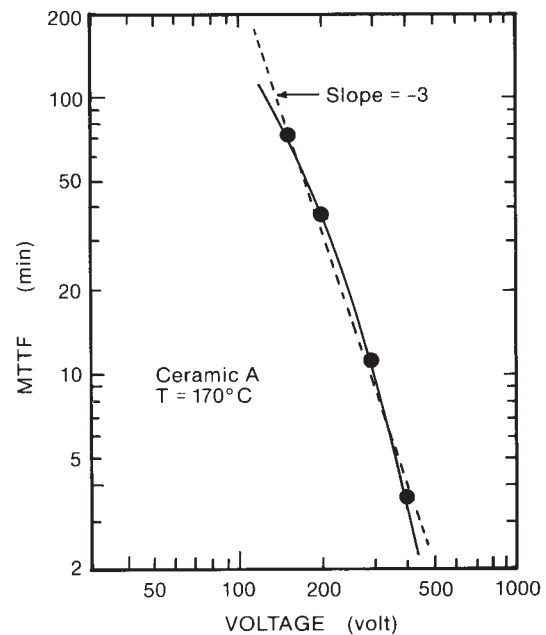
The voltage acceleration for ceramic A failed by thermal runaway is shown in Figure 5. The trend of the data does not indicate a constant slope. If a “best fit” curve is drawn, the tangent of the curve would vary from about -2 at 150 volts to about -4 at 400 volts. This suggests that a constant exponent,  $n$ , in the term

Figure 5. Voltage Acceleration of Ceramic A Failed by TRA

is not a true representation of the voltage acceleration factor. Minford<sup>1</sup> also saw an exaggerated acceleration at high voltage (400 volts). The non-linearity in the voltage acceleration exponent explains the reasons for the inconsistency in the values reported by various previous investigators. A value of 3 is normally accepted in the industry of ceramic capacitors.

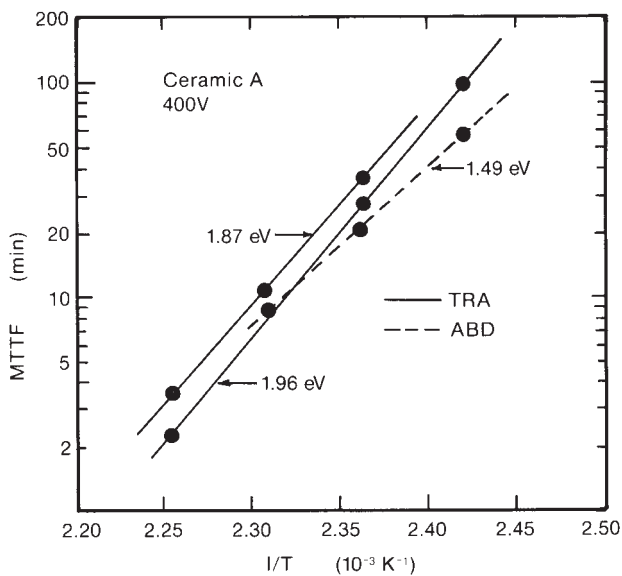
The acceleration by temperature is shown in an Arrhenius plot of MTTF in Figure 6. Two groups of ceramic A were evaluated here. For the failure by TRA, the pseudo activation energy is 1.87 eV for Group 1 and 1.96 eV for Group 2. For the failure by ABD, the pseudo activation energy is 1.49 eV for Group 2 and undetermined for Group 1 due to an extremely low failure population by this mechanism. These values of pseudo activation energies are much higher than any other values reported earlier. The

Figure 6. Arrhenius Plot of MTTF of Ceramic A Tested at 400 VDC

large discrepancy is not in the accuracy of measurements, but the uncertain physical meaning of the definition of the pseudo activation energy. The MTTF cannot be described as a simple activation process which involves overcoming a certain energy barrier. It is determined from the accumulation of various degradation processes which depend on the combination of various imperfections described earlier. Therefore, the MTTF, although thermally activated, does not have a clear physical meaning as related to the activation energy at this time. This is because of the complicated nature of degradations from various imperfections. This complication resulted in a large discrepancy of pseudo activation energies from one material to the other. Even two identical lots of a material prepared at different times can produce a significant discrepancy. With a large uncertainty in value and physical meaning, it is only appropriate to call it a pseudo activation energy.

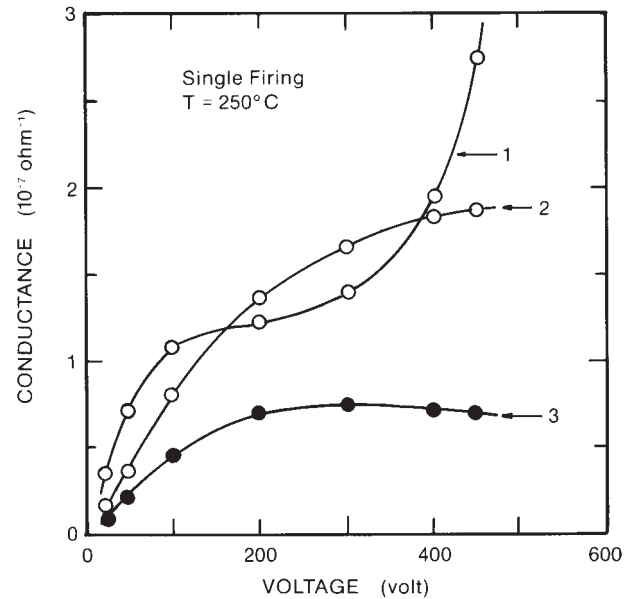
Three mid-K dielectric materials were especially prepared in the laboratory for this study. All ingredients were the same except for a different grade related to the purity of  $\text{BaTiO}_3$  used in each dielectric material. Figure 7 shows the results of current-voltage measurements at  $250^\circ\text{C}$  plotted as the conductance ( $i/V$ ) versus voltage. At this temperature, all these ceramics are nonohmic near the low voltage end. The trend is ohmic as the voltage is increased. However, ceramic 1 reverses the trend as the voltage exceeds

Figure 7. Conductance ( $i/V$ ) as a Function of Voltage of Three Ceramics Tested at  $250^\circ\text{C}$ . Dielectric Thickness was  $45\ \mu\text{m}$

250 volts. This reversal of the trend indicates the weakness of the ceramic to withstand the stresses. Current monitored life test at  $250^\circ\text{C}$ , 450 volts certainly shows that ceramic 1 is the weakest ceramic of the three. It fails by TRA with a mean time to failure of 2.3 hours, whereas ceramics 2 and 3 fail by ABD with MTTF of 24.5 hours and 36 hours, respectively.

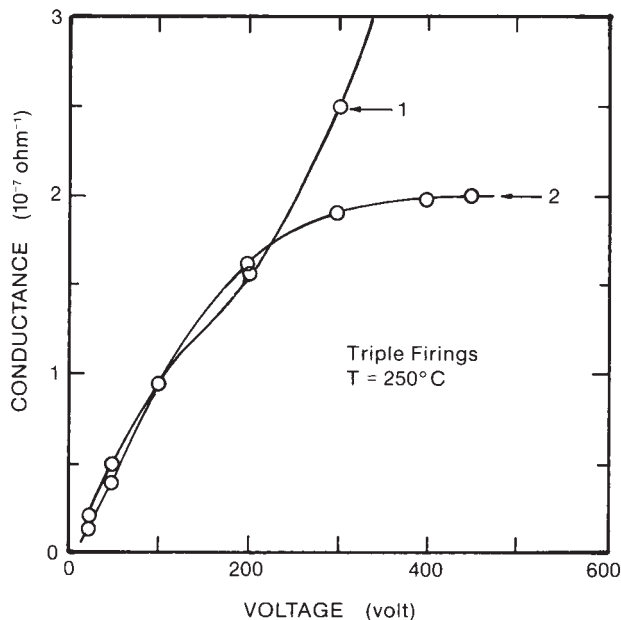
Triple firings of ceramic materials 1 and 2, respectively, resulted in additional grain growth. Their conductances versus voltage are shown in Figure 8. Noticeable increase of conductance was observed in each ceramic, especially in ceramic 1. The increase of conductance suggests shorter life for these ceramics. And, indeed, ceramic 1 was found to fail by TRA with a MTTF of 0.75 hour and ceramic 2 failed by ABD with a MTTF of 21.6 hours tested at  $250^\circ\text{C}$ , 450 VDC.

Figure 8. Conductance ( $i/V$ ) as a Function of Voltage of Two Refired Ceramics Tested at 250°C. Dielectric Thickness was 45  $\mu\text{m}$

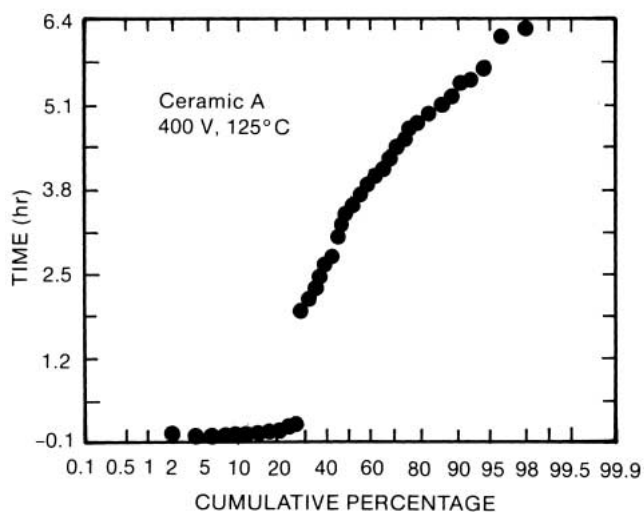
To use life test or burn-in as a screening technique, first we need to establish an effective test condition. Figure 9 shows a typical normal probability plot of life test failures of laboratory sample ceramic A at 400 V,  $125^\circ\text{C}$ . A clear separation of two populated groups is shown. If one does the burn-in at the condition for 1 hour and keeps the survivors, one would have a better than 90% elimination of the infant mortality. When tested at twice rated voltage and rated temperature, it is found that survivors have a failure rate of at least one to two orders of magnitude lower compared to the control lot. Table 1 shows the percentage of infant

Figure 9. Normal Probability Plot of Life Test Failures of Ceramic A Tested at 400 VDC, 125°C

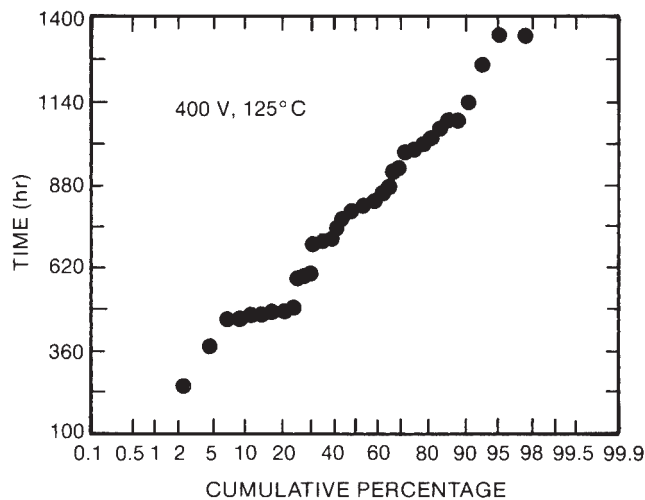
By using life test as a source of feedback, great improvement of the ceramic body and its control of production process can be achieved. Figure 10 indicates such an improvement as a commercial ceramic derived from the understanding of the various imperfections mentioned earlier and the various types of BaTiO<sub>3</sub> materials employed in the base ceramic. An improvement of the MTTF by at least two orders of magnitude is obvious. This information, coupled with the voltage and temperature accelerated conditions, can be further used to improve the reliability to better than ppm levels.

Figure 10. Normal Probability Plot of Life Test Failures of a Control Group Free of Physical Flaws, Tested at 400 VDC, 125°C
